ENHANCED ZONAL ANALYSIS PROCEDURES

PROGRAM TO ENHANCE AIRCRAFT ELECTRICAL WIRING INTERCONNECTION SYSTEM MAINTENANCE

Appendix A. Enhanced Zonal Analysis Logic Diagram and Steps

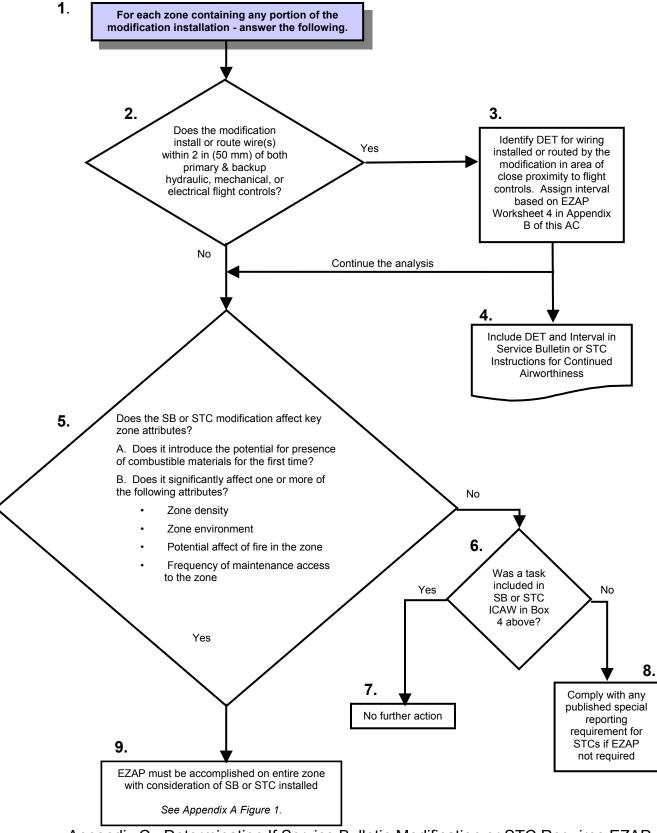
Appendix C. Figure 1. Determination if Service Bulletin Modification or STC Requires EZAP

Appendix C: Determination If Service Bulletin Modification or STC Requires EZAP
